COQUILLE RIVER

[Local Sponsor: Port of Bandon]

**OFFSHORE DREDGED MATERIAL DISPOSAL
Coquille Section 102 Disposal Site
Survey Date: 21 June 2010
6' Contours**

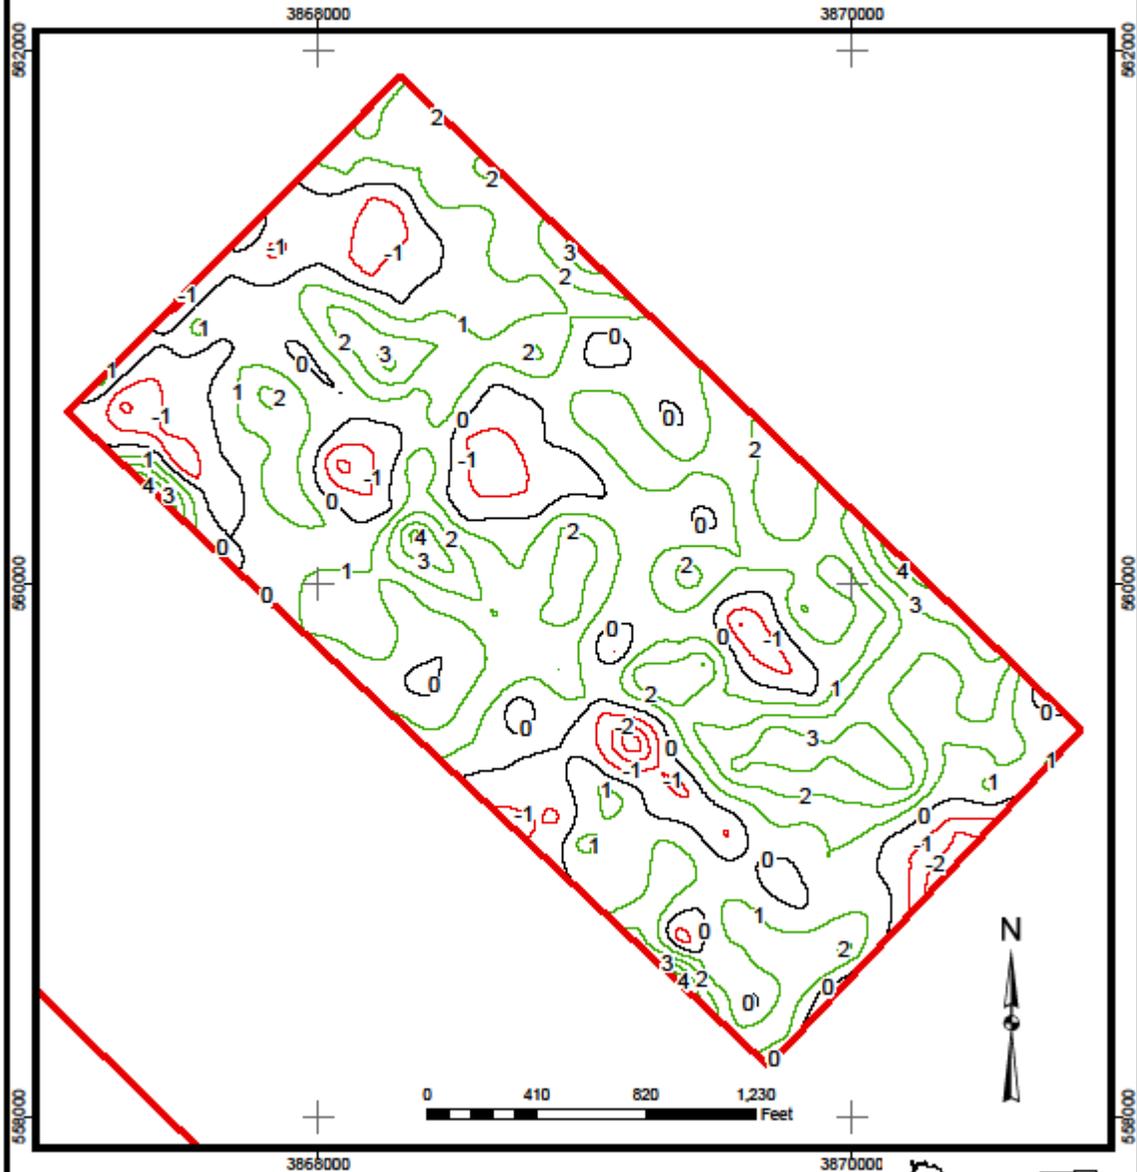
OFFSHORE DREDGED MATERIAL DISPOSAL Coquille Section 102 Disposal Site

Survey Dates: 21 June 2010 & 11 May 2009
1 Foot Contours of Change from 2009 to 2010

Horizontal Coordinate System:
NAD83, State Plane Oregon South, U.S. Survey Feet
Vertical Datum:
Mean Lower Low Water (MLLW)

Beginning in **1992**, CENPP-OP-NWH was notified of requirements for annual bathymetric surveys of all ODMDSs as a Tier I monitoring requirement. Monitoring has indicated no mounding or other reasons to modify present management practices at this location. Continuation of present management and monitoring practices is recommended to meet project and regulatory obligations. Special studies such as sidescan sonar surveys or benthic infauna and sediment characterization should be conducted as needed.
